REPORT: Model Separate Storm System Surveying & Monitoring Berkshire Environmental Action Team (BEAT)

Grant Awarded: September 2015
Grant Completed: June 2017

REPORT: Model Separate Storm System Surveying & Monitoring

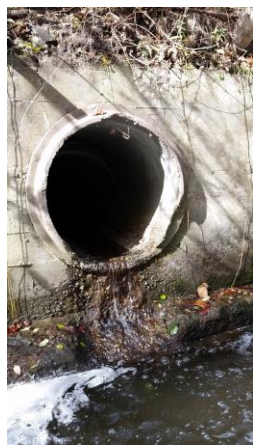
The third outfall, identified as WB410, is located at the southernmost end of Wyandotte Business Park, behind an old fence and the southernmost brick building. Volunteers described the rate of flow as “moderate”, the odor as “sewage”, and the condition as “minor damage”. What’s more, there is a sewer line running past the outfall. Also, this outfall did not appear on the City of Pittsfield’s Storm Water System map or GIS layer. Due to these characteristics, BEAT decided to sample this outfall.

WB410 was tested on five occasions by a certified lab and one time by students from BCC’s microbiology lab. Results obtained both sources indicate that there is a serious contamination issue. Lab results were 1732.9 MPN/100ml, 2419.6 MPN/100ml, >2419.6 MPN/100ml, >2419.6 MPN/100ml, and 648.5 MPN/100ml. The geometric mean for these five samples is BCC students were not able to obtain a result via plating and counting colony forming unit due to the extreme concentration of fecal coliform.

In relationship to state regulations, this outfall tested well outside the individual 235 cfu/100ml limit for all five samples. Moreover, it’s geometric mean of 1739.3 is well above the 126 cfu/100ml permitted.

State reg	Sample 1	Sample 2	Sample 3	Sample 4	Sample 5
235	1732.9	2419.6	>2419.6	>2419.6	648.5

BEAT is pressuring the City to remediate this situation. BCC students will continue to sample and test this outfall.

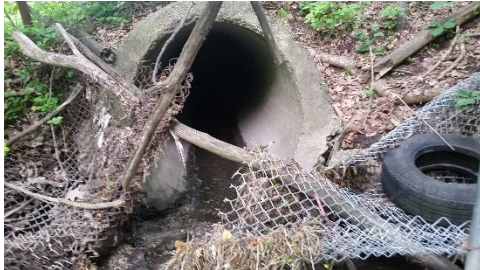
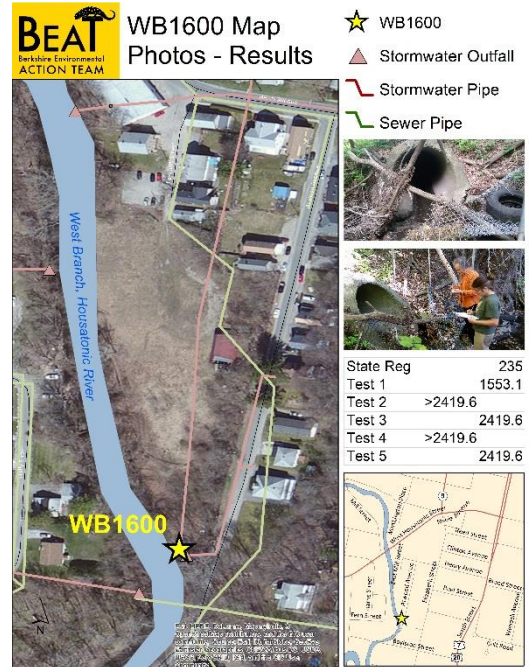
The sixth outfall, identified as WB1600, is located along Atwood Drive in a forested section of the river between residential areas. Volunteers described the rate of flow as “minor” and the odor as “sewage”. Also, there are a considerable number of locations where sewage lines cross the stormwater pipe.

WB1600 was tested on five occasions by a certified lab and four times by BCC’s microbiology lab. Results obtained by both sources indicate a serious contamination issue. All five of the lab samples tested significantly higher than the state limits and the geometric mean of the five samples was 2214.3, well above the state limit 126.

State reg	Sample 1	Sample 2	Sample 3	Sample 4	Sample 5
235	1553.1	>2419.6	2419.6	>2419.6	2419.6

BCC students were not able to obtain a result via plating and counting colony forming units due to the extreme concentration of fecal coliform in the sample. Professors actually tried diluting samples in order to obtain a result but samples were still too concentrated. These experiences caused one of the BCC professors to query whether or not the discharge may actually be “raw sewage”.

BEAT considers this outfall to be a priority for remediation. BEAT is pressuring the City to remediate this situation. BCC students will continue to sample and test this outfall.

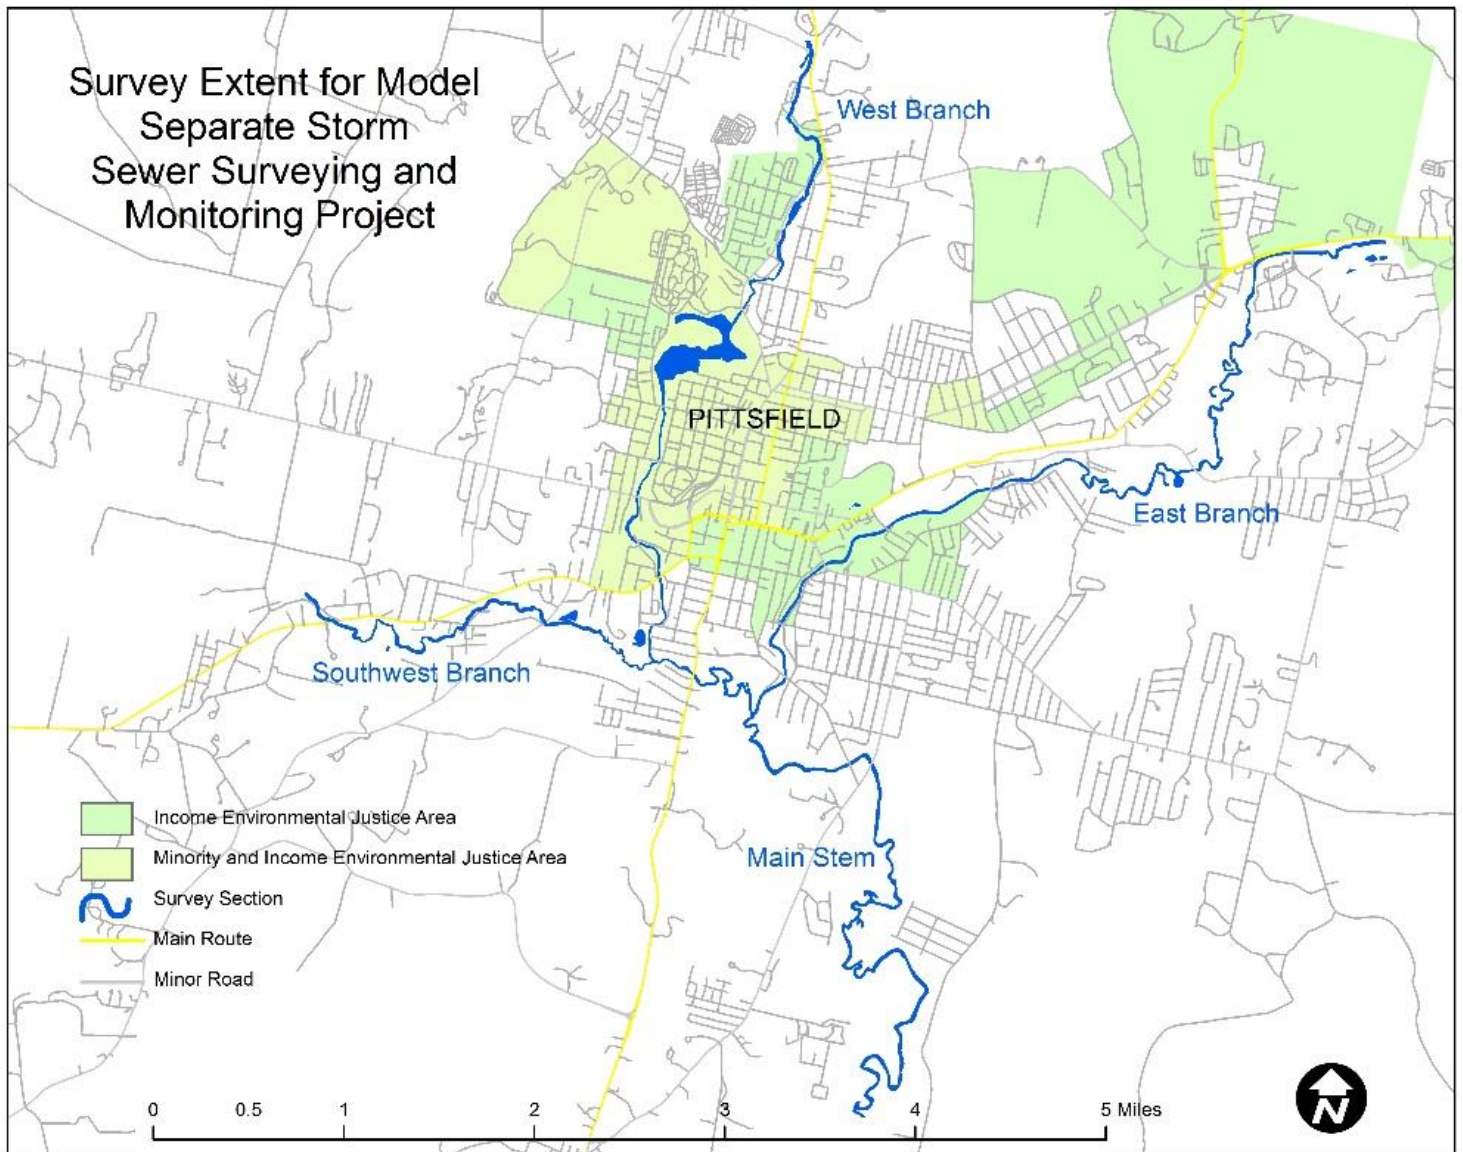
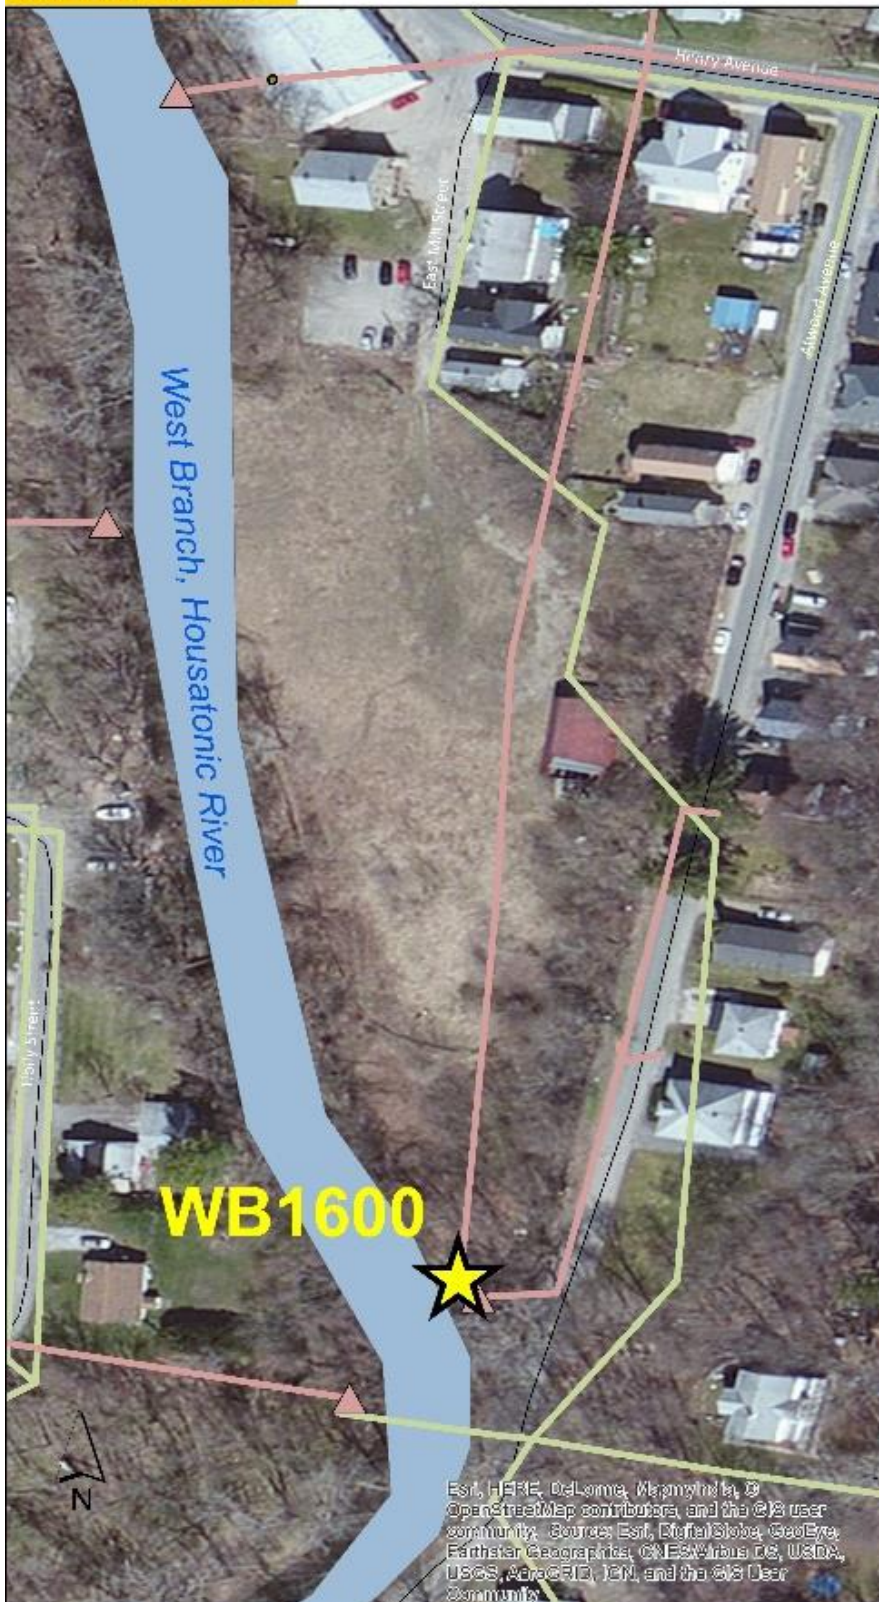
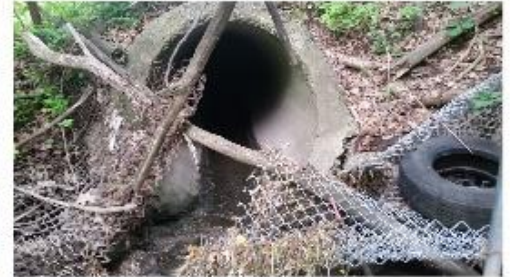
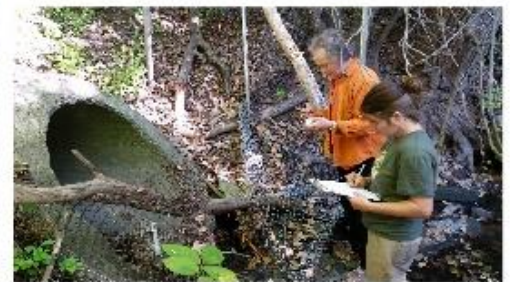
WB1600 Map Photos - Results

State Reg	235
Test 1	1553.1
Test 2	>2419.6
Test 3	2419.6
Test 4	>2419.6
Test 5	2419.6
